# **CERG 2003**

## **“Risk analysis in Cerro El Volcan in the context of design of a landslide monitoring system”**

**Dipilto Municipality, Nueva Segovia, Nicaragua**

**Anne-Sophie GREGOIRE**

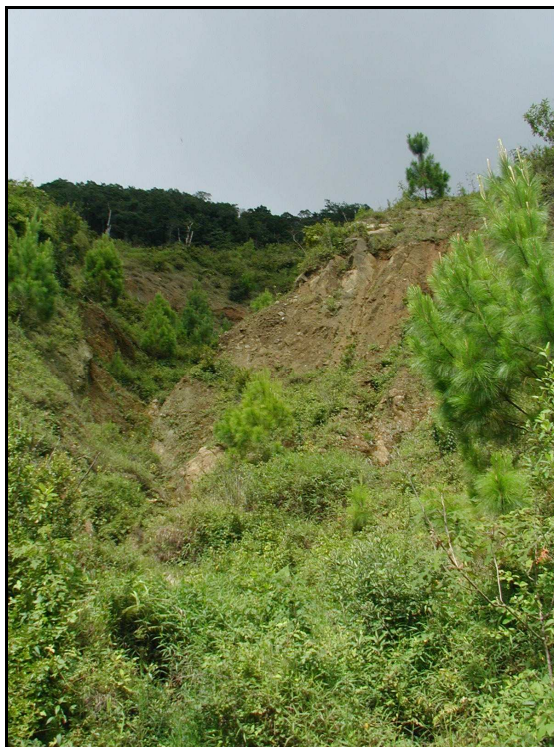
Volcan quebrada up to Cerro El Volcan, it was observed that erosion is very important and numerous other quebradas, up to 20m high were also present (*see photo 1*).

*Photo 1: Quebrada El Volcan showing the high degree of erosion.*

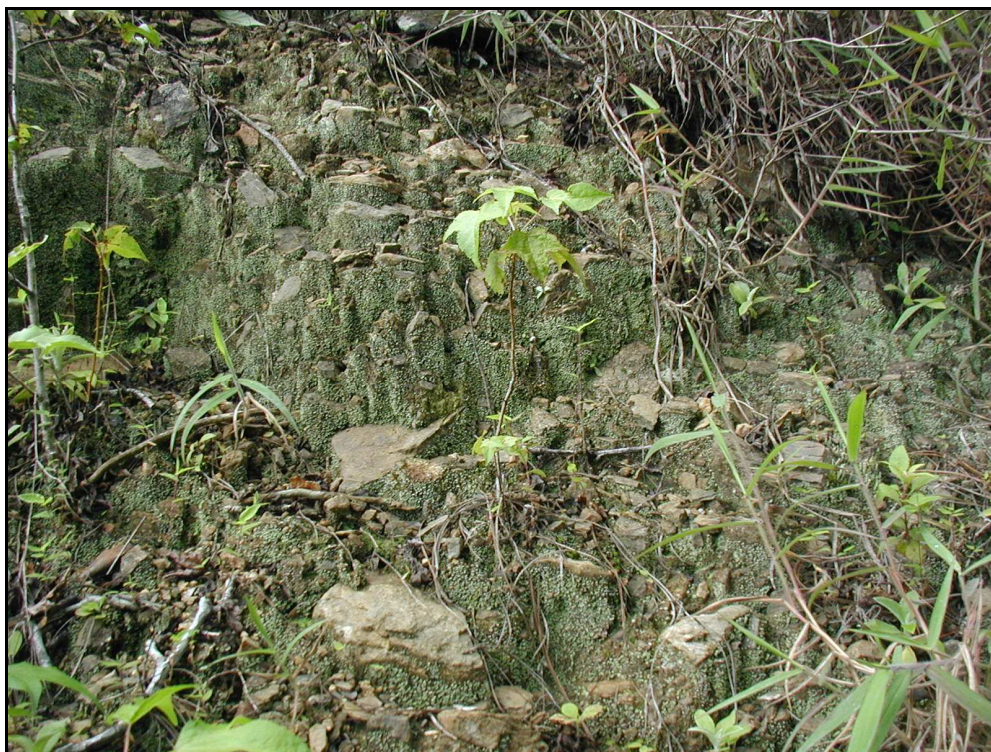
*Photo 2: Deposits coming from anterior movement in El Volcán quebrada.*

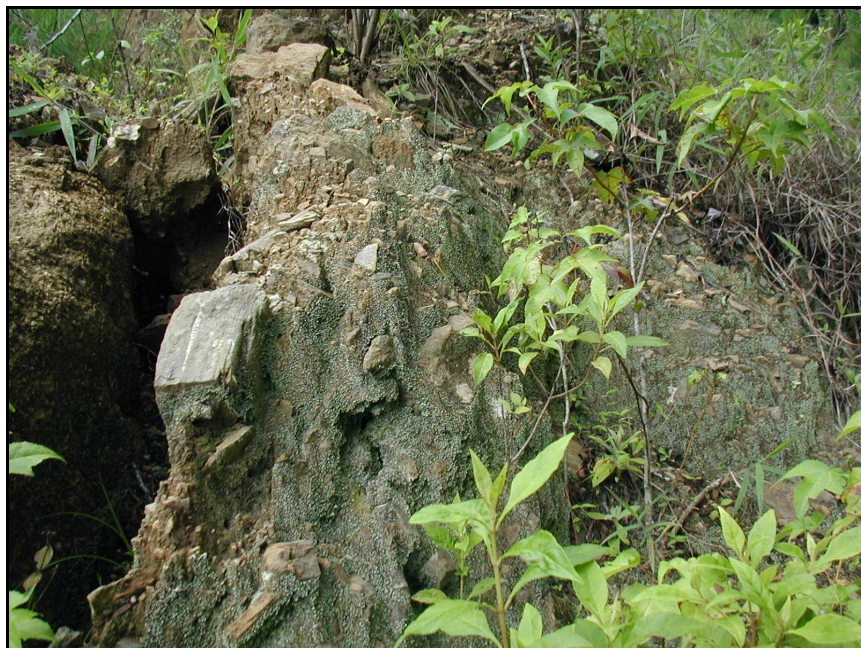
*Photo 3: Fractured granite on the side of El Volcan quebrada.*

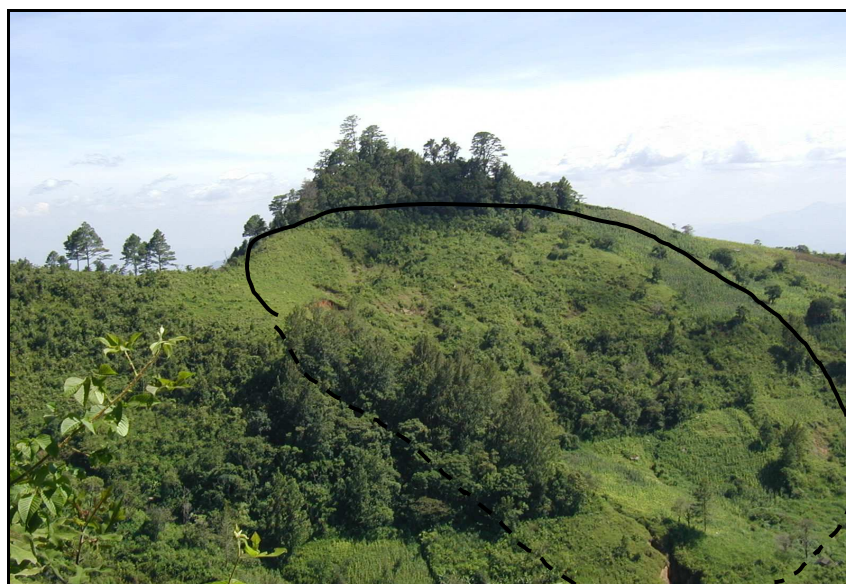
**Arado** is a rotational landslide located on the western slope of Cerro Mojón del Matasanito (see photo 5). It shows a high degree of activity indicated by numerous scarps, superficial movements, debris flows and coladas. This movement could affect the numerous cultures of El Volcan. It was initiated by Hurricane Mitch and the process is in acceleration. There are associated debris flows in the frontal and lateral parts moving the direction of El Volcan quebrada. There are tall plants (up to two meters high) and trees growing on the landslide.

*Photo 5: View of Arado. The main scarp is 6-8m high, about 30m wide. The black line indicates the limit of instable zone.*

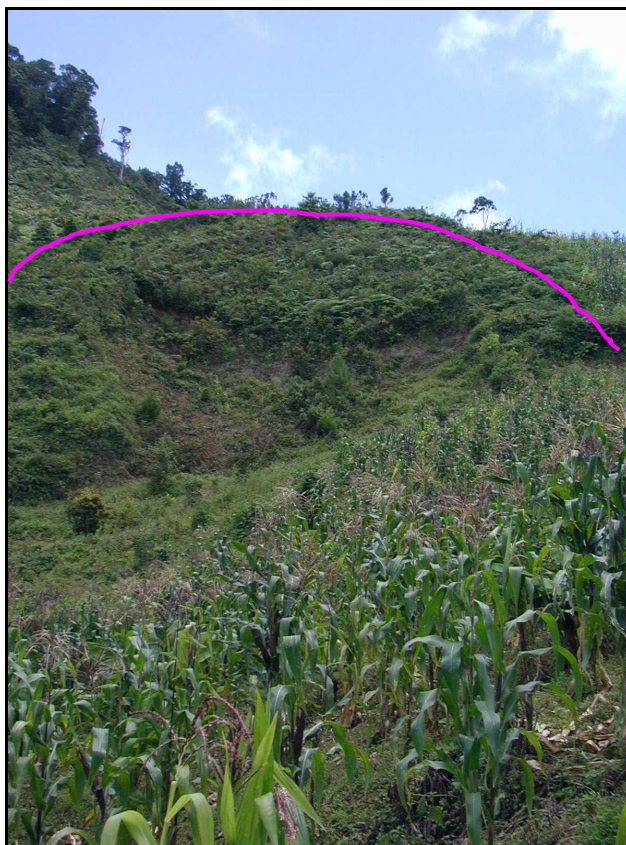
**Compartment 1** is an active rotational landslide with scarps 3-8m high and 50m wide .It has associated debris flows from its lower part. It is separated from Arado and compartment 2 by stable areas (see photo 6).

*Photo 6: View of the top of compartment1 located below Cerro El Volcan Viejo (from casita).*

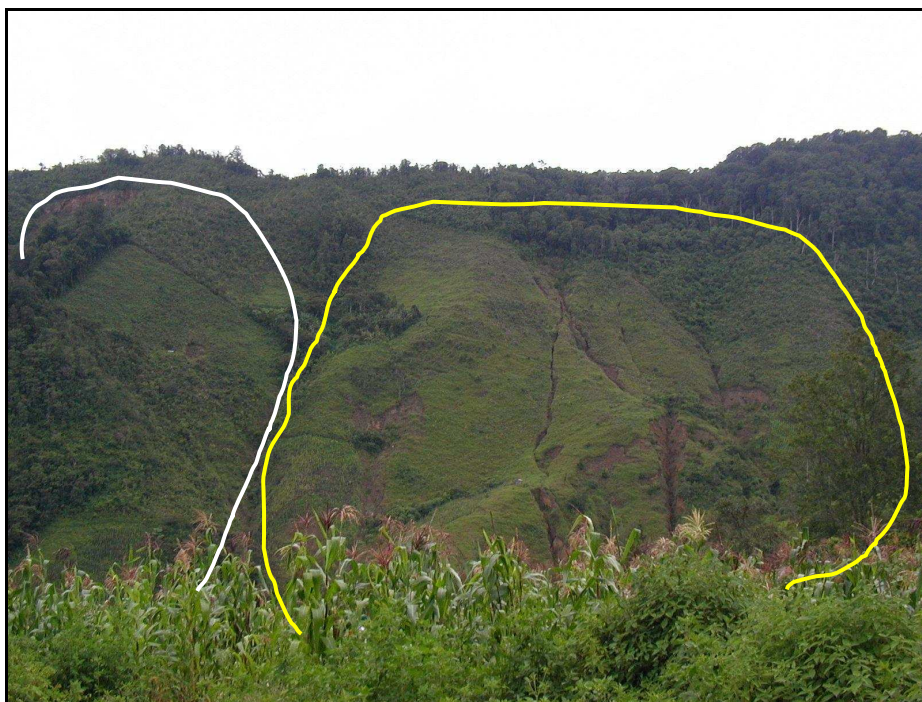
**Compartments 2 and 3** are superficial movements with scarps 3-5 m high. There is no evidence of rotational movement. We observe numerous quebradas and old debris flows in contact with grey, fractured and altered metamorphic rocks. The soil is meteorized, of pink colour and has high clay content. There are no trees, only tall plants. See photo 7 for a general view of the two compartments, then photos 8 and 9 for more detailed view.

*Photo 7: Global view of compartments 2 (right) and 3 (left) from Cerro El Torre.*

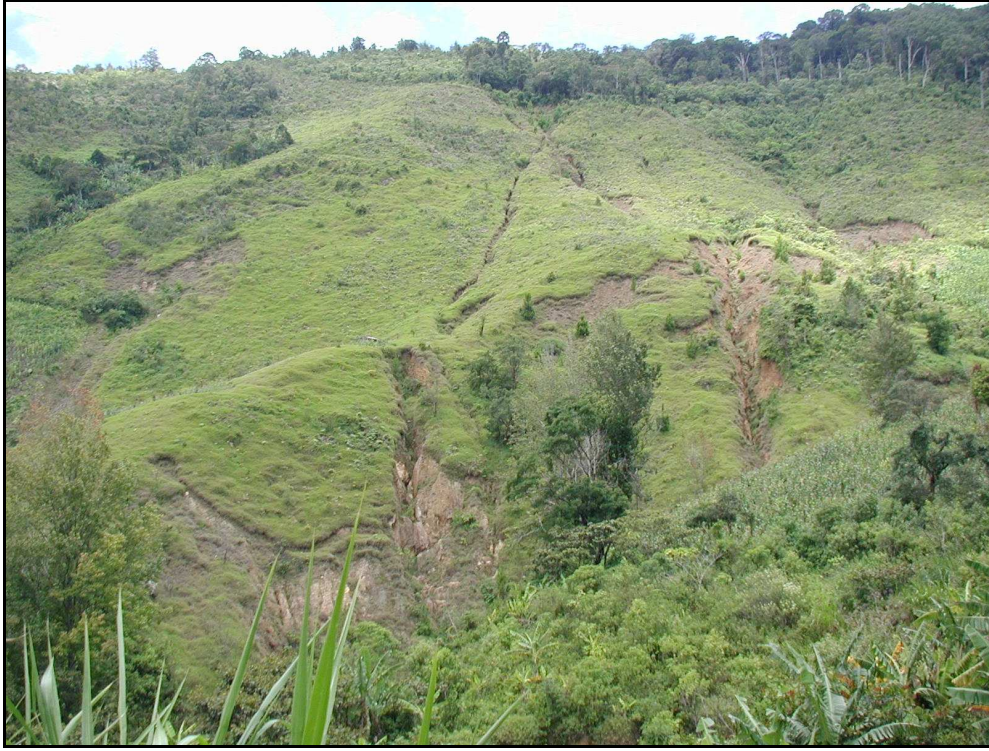
*Photo 8: Compartment 2 with superficial movements and quebradas. Signs of debris flows. View from Arado.*

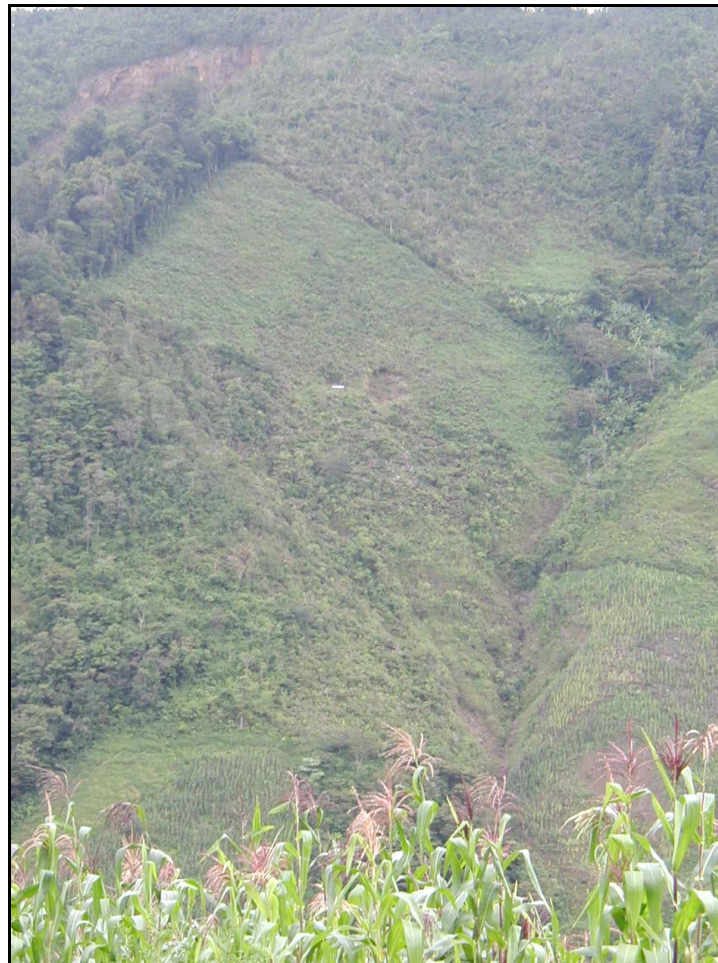
*Photo 9: Compartment 3 with superficial movements, old scarps and quebradas. View from El Torre.*

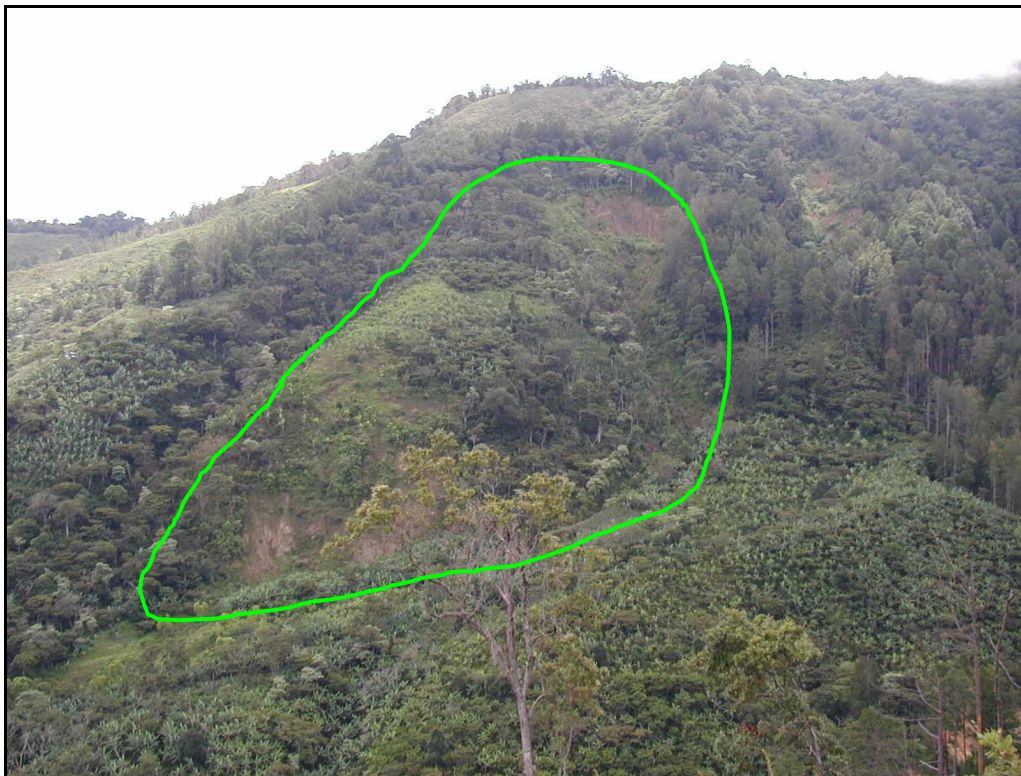
**Compartment 4** is located just above the Cooperative El Volcan (*see photo 10*). This is a rotational landslide: it is deeper than compartments 2 and 3 and is surrounded by two small quebradas which, during Mitch, brought debris down to the Cooperative damaging the house (fortunately people were evacuated beforehand). The scarp closest to the Cooperative is 5-10m high and 100m long. We observe many inclined trees and the slopes are steep.

*Photo 10: View over compartment 4 from the hill above the cooperative (located on the left bottom).*

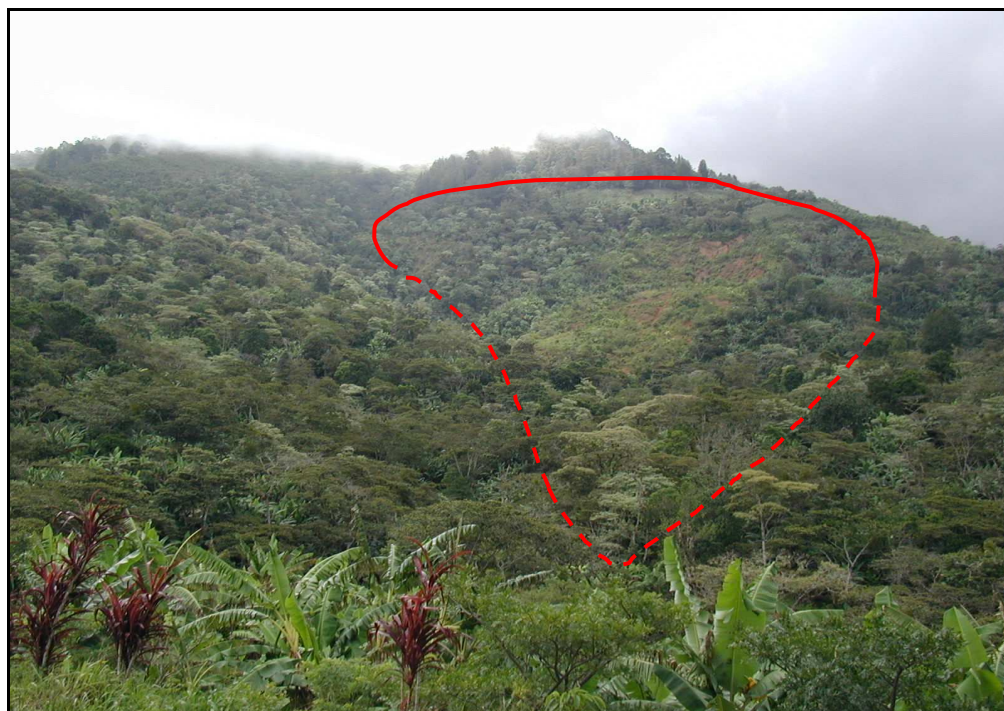
**Compartment 5** is a superficial rotational landslide which has different directions of movement in its upper and lower parts (*see photo 11*). There are intrusive rocks with a high degree of degradation. Here also, trees are inclined and slopes steep. Scarps are 5-20m high. The water content is higher than in the other compartments and some areas were very wet.

*Photo 11: View over compartment 5 from the little church (capilla) in Las Nubes.*

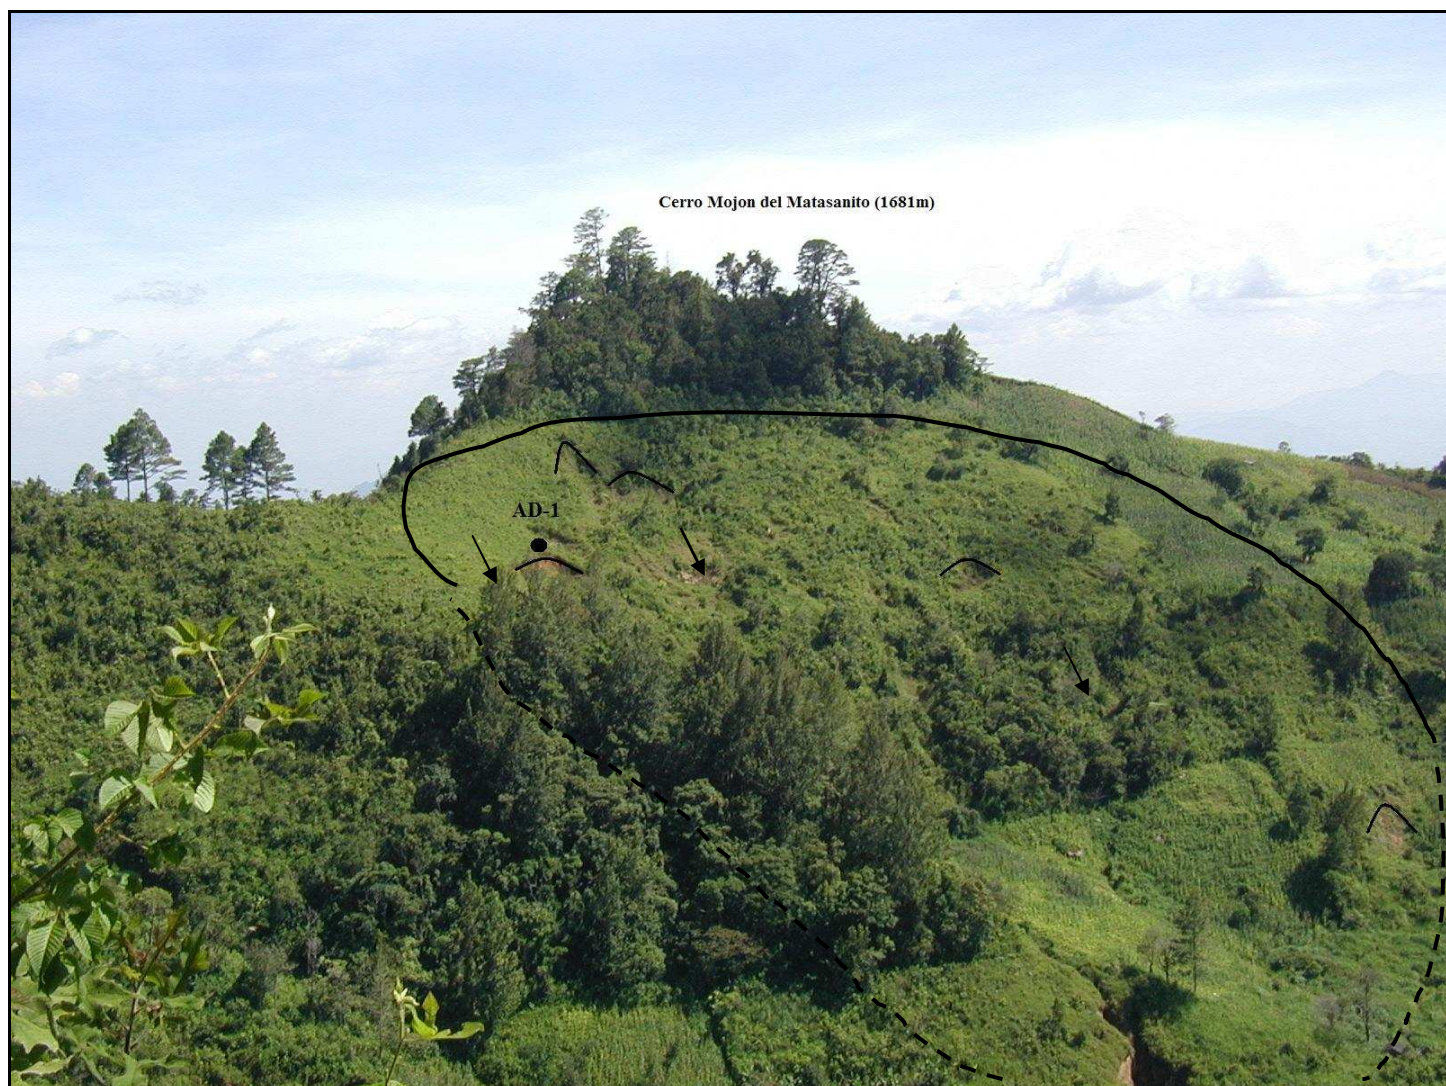
There is just one monument in this compartment called AD-1 (*see photo 21*). There are two routes of accesses; one from la quebrada El Volcan along the crest to the south and one along El Torre crest, south of the cooperative.

***Photo 21:*** Localisation of the monument in Arado compartment above the most important scarp. ***The black arrows indicate the direction of the mass movements.***

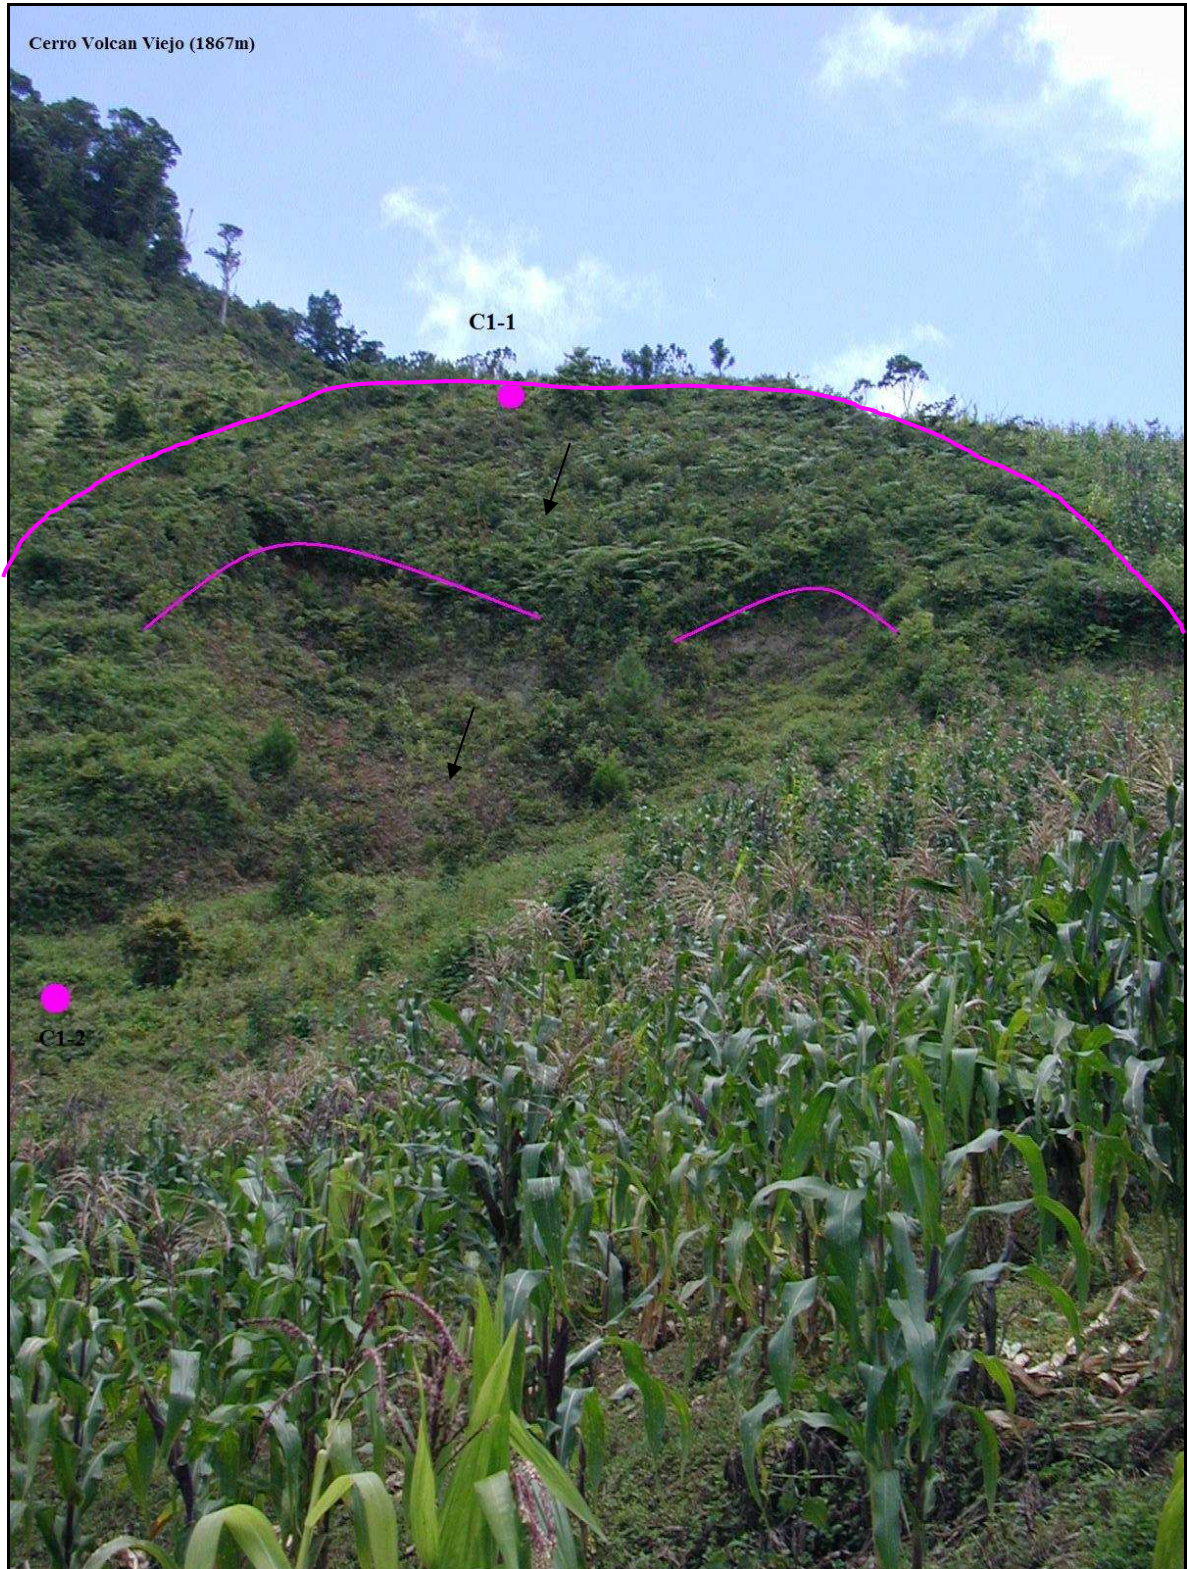
Two monuments (VD-1-1 and VD-1-2) have been setup, above and below the main scarp located at the pass between Cerro El Volcan Viejo and Mojon Del Matasanito (*see photo 22*). There are also movements higher up but access is prevented by the presence of land mines. Many have been removed since the end of the war in 1990 but plenty were not mapped and, in addition, were remobilized because of heavy rains and landslides (especially with Mitch). Therefore, the upper zone is still not clean and it's not safe to explore.

***Photo 22:** Localisation of the monuments in compartment 1. These are called VD-1-1 (high) and VD-1-2 (lower part). The black arrows indicate the direction of the mass movements.*

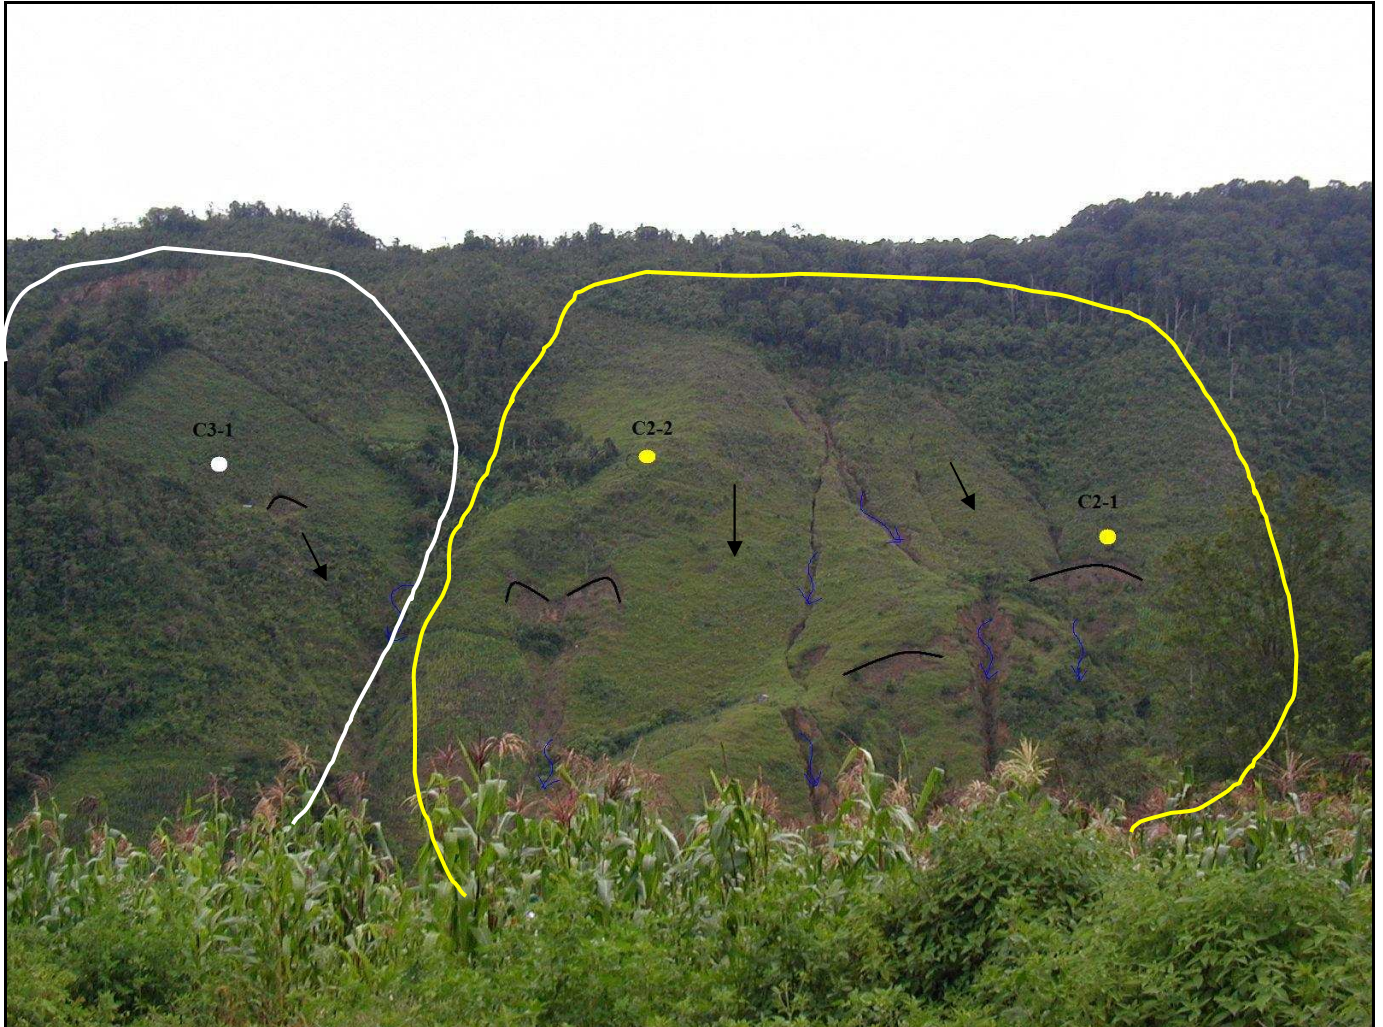
There are three monuments, two in the second compartment and one in the third, respectively called VD-2-1, VD-2-2 and VD-3-1 (*see photo 23*). We were unable to setup more points because access is very difficult. There is no path; we have to go first from El Volcan quebrada through the corn field then up a steep path created with machetes during the field work.

*Photo 23: Localisation of the monuments in compartments 2 and 3. From right to left (south to north), we have VD-2-1, VD-2-2 and VD-3-1. The black arrows indicate the direction of the mass movements, the blue lines the direction of the debris flows.*

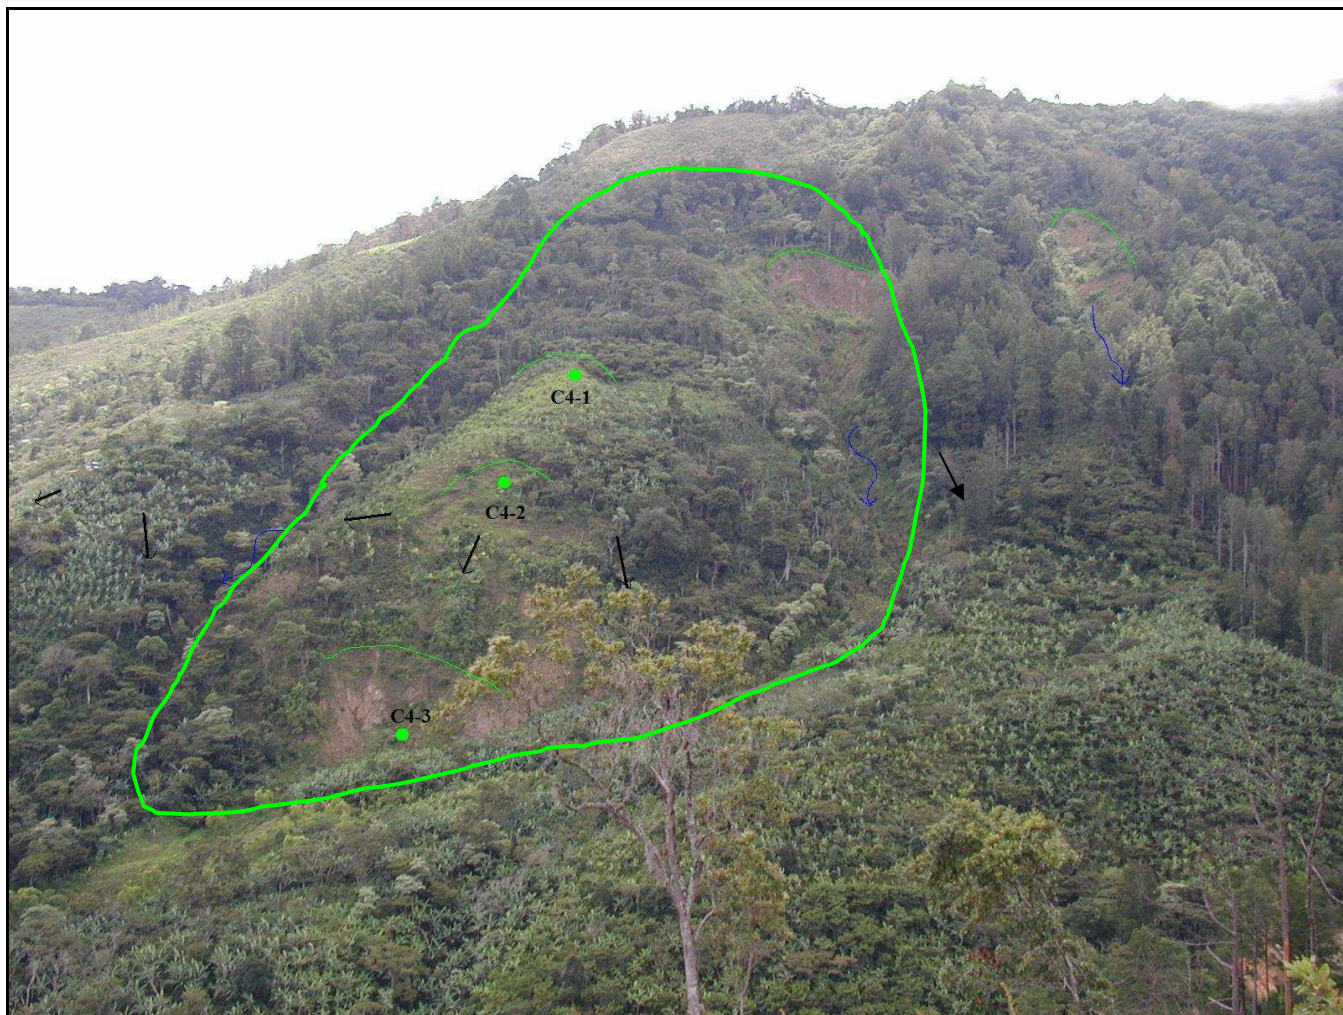
This is the most hazardous for people and plantations zone as it is located just above the cooperative. We chose to setup three monuments, ranging from 1350 to 1500m altitude, above and below the main scarps, called from top to bottom VD-4-1, VD-4-2 and VD-4-3 (*see photo 24*). There is another scarp higher up but it is inaccessible due to the presence of mines.

*Photo 24: Location of the monuments in compartment 4. From top to bottom; VD-4-1, VD-4-2 and VD-4-3. The black arrows indicate the direction of the mass movements, the blue lines the direction of the debris flows. On the left, we have compartment 5.*

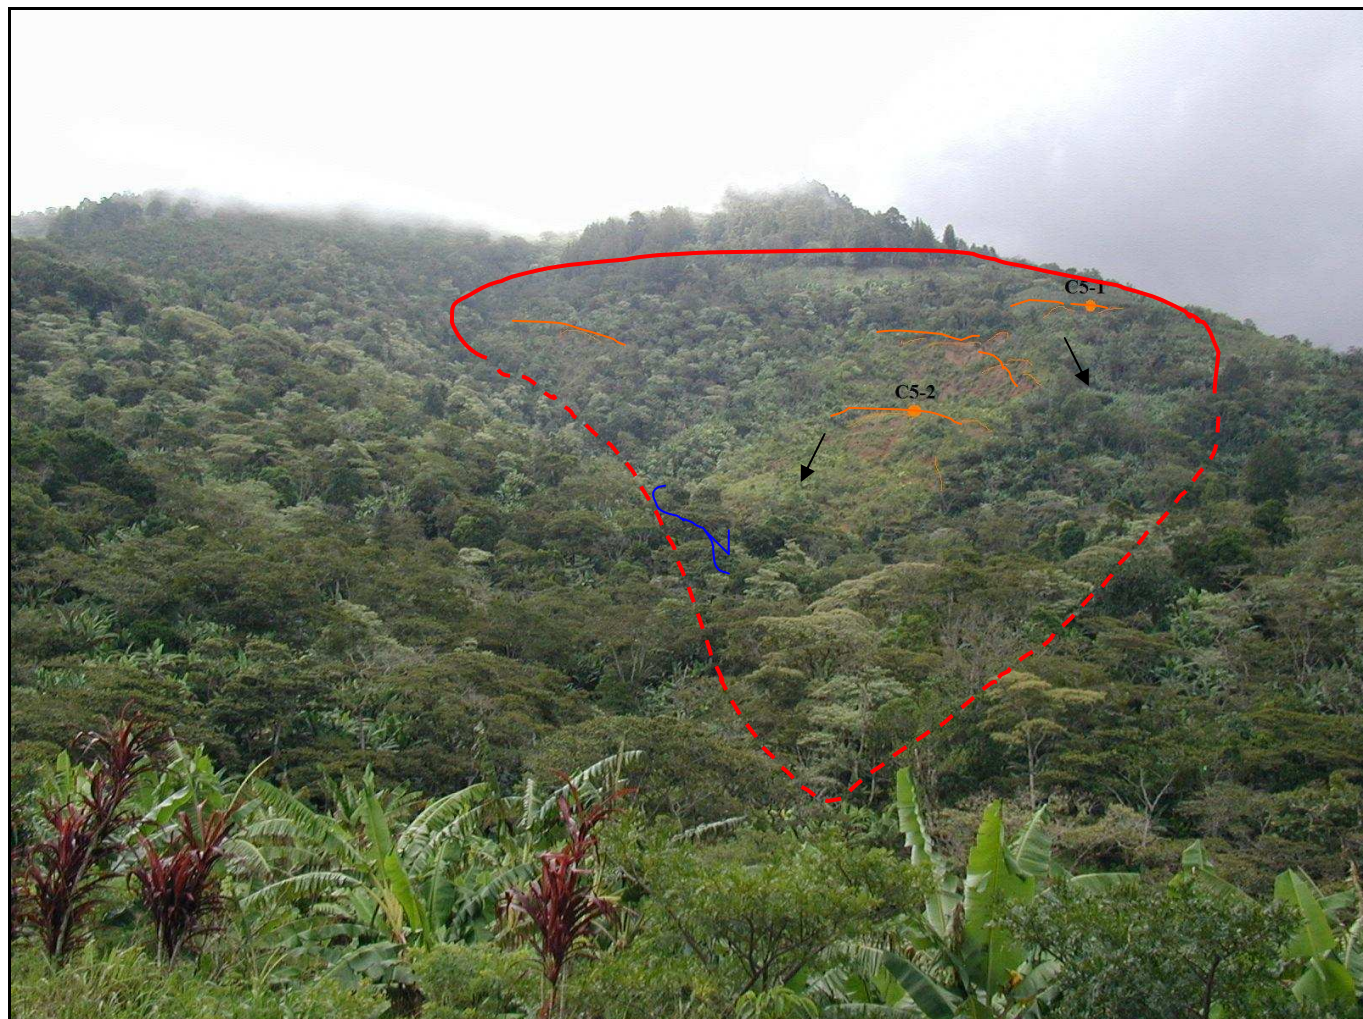
Two points are setup. The highest is close to a small cooperative. There are many coffee and corn plantations. It is impossible to walk further up and to the north (where there is the left scarp). Below the lower point VD-5-2, there is a succession of minor scarps which would be good to monitor. However, there is a high water content in these zones (even in dry weather) and it would be difficult to erect monuments.

*Photo 25: Location of the monuments in compartment 5. From top to bottom (south to north; VD-5-1 and VD-5-2. The black arrows indicate the direction of the mass movements, the blue line the direction of eventual debris flows.*
