# **CERG 2003**

## **“Risk analysis in Cerro El Volcan in the context of design of a landslide monitoring system”**

**Dipilto Municipality, Nueva Segovia, Nicaragua**

**Anne-Sophie GREGOIRE**

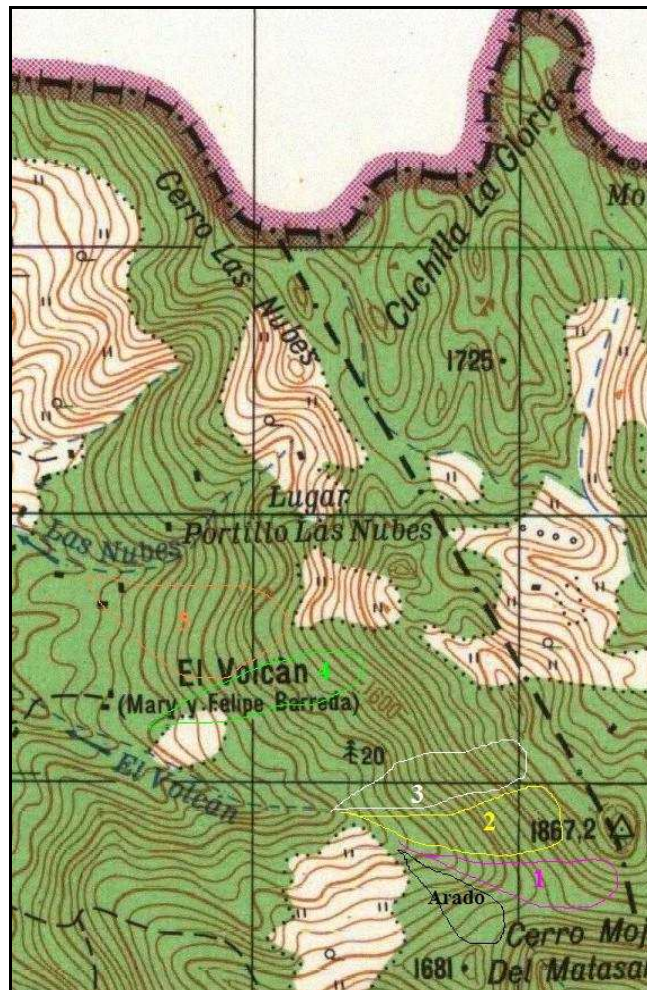
Before Mitch, the landslide was only rotational. The heavy rains of 1998 subsequently weakened the area and the landslide evolved into complex, mixed and permanent phenomena. Several compartments are now isolated and evolve differently. The total unstable mass occupies the entire west flanks of Cerro El Volcan and Cerro Mojon Del Matasanito. Its extension is great, about 3 km length and over 500m in elevation. During the field work, the most active areas of the landslide were identified: Five areas on the west flank of Cerro El Volcan Viejo (henceforth called compartment 1 to compartment 5 respectively) and one compartment on Cerro Mojon Del Matasanito (henceforth called Arado). See *figure 4* for compartments locations and *photo 4* for a general view of the area.

*Figure 4:* Localisation of the compartments (Arado in black, C1 in purple, C2 in yellow, C3 in white, C4 in green and C5 in orange).

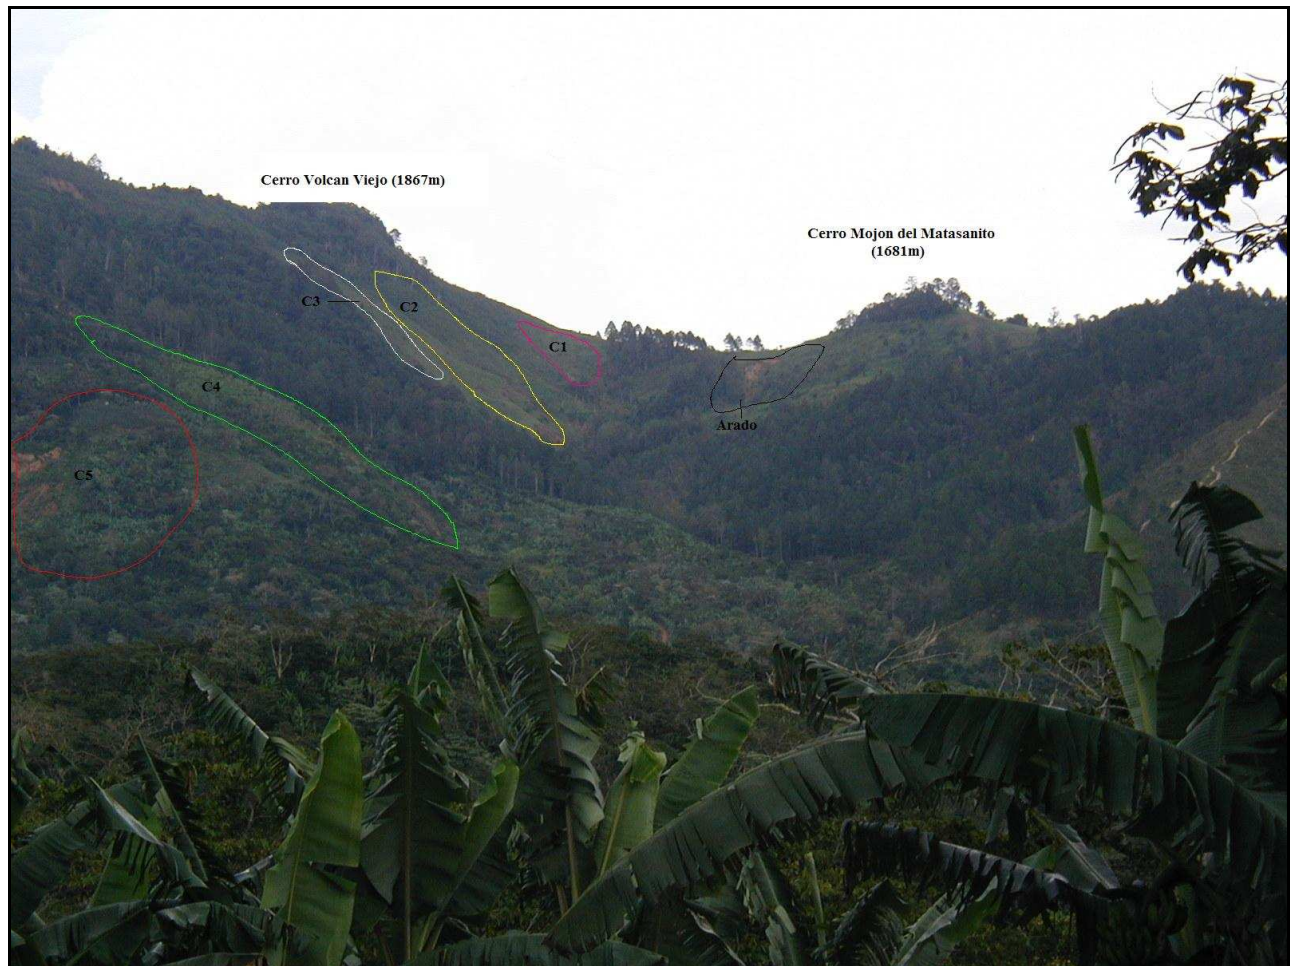
*Photo 4: General view from La Tablazon with the compartments and localisation of the Cerros.*

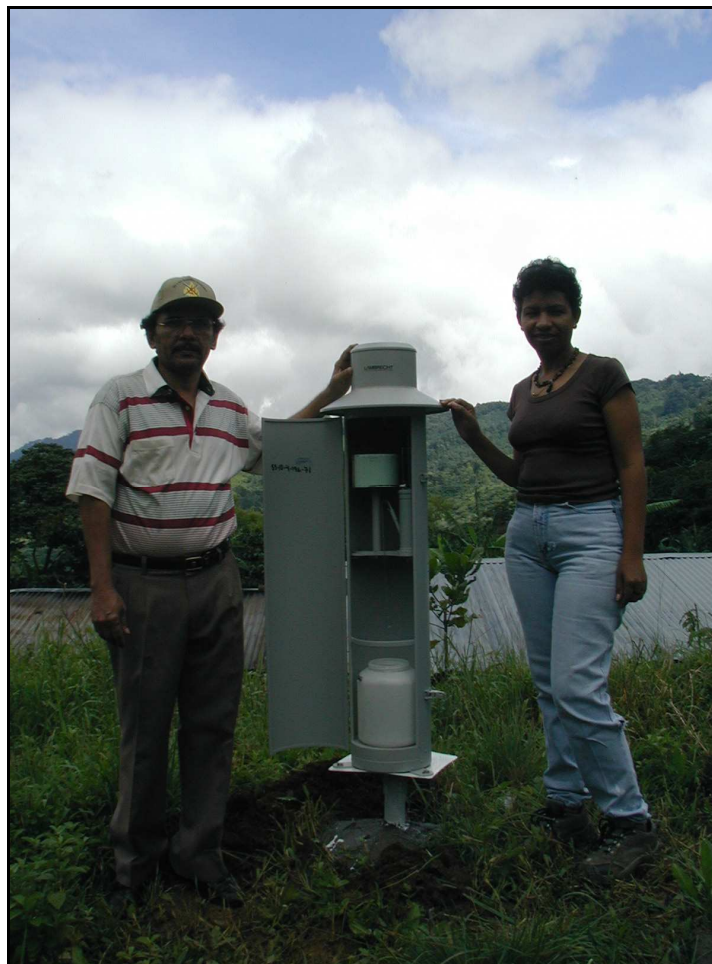
The first site selected was the Cooperative in El Volcan where we installed a pluviograph (*see photo 15*) and pluviometer. Here, there is a permanent settlement of about 20 people and it is directly affected by any landslides and/or debris flow. The hacienda was partially destroyed during Hurricane Mitch in 1998. The people feel very concerned and are keen on helping us. According to the locals (and verified by us during the field work), this site receives more rain than Dipilto and areas located further down. This is due to its location surrounded by high summits. Clouds get stopped by these high summits and discharge the rain.

*Photo 15: Pluviograph in El Volcan Cooperative (surrounded by Saul Flores and Miriam Down).*

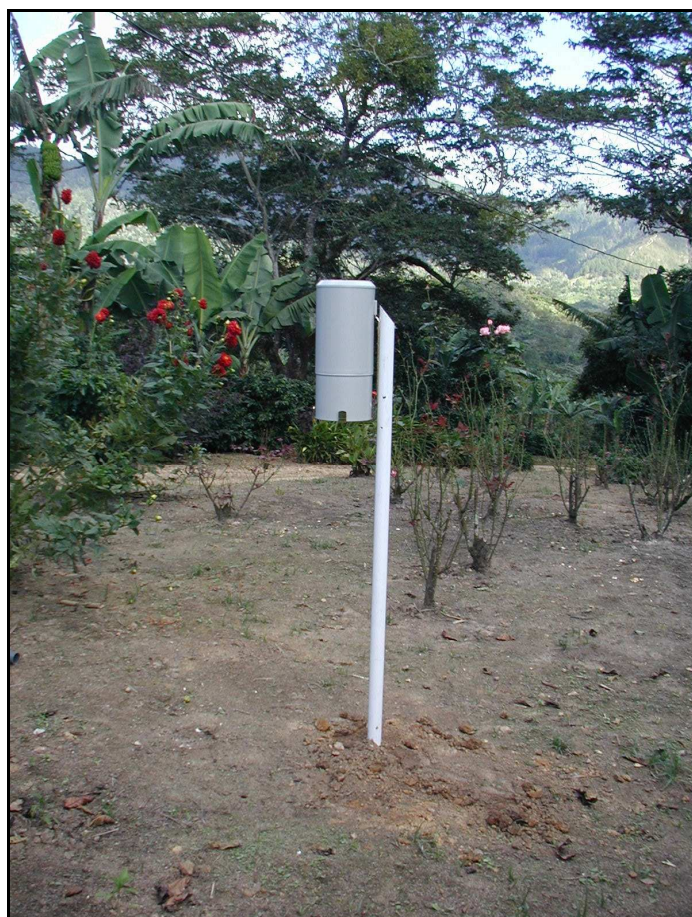
There are already three meteorological stations in the area, in Las Planos (next to Las Manos), La Laguna (Dipilto Nuevo) and Ocotul. The other pluviometer was setup, away from the unstable zone, in La Tablazon approximately 3km west from the Cooperative (*see photo 16*). Added to the existing stations, data interpolation will be more accurate and information about the behaviour of the studied zone more precise. Below are the coordinates of the stations in Latitude/Longitude and UTM (datum NAD27-Central).

*Photo 16: Pluviometer in La Tablazon.*

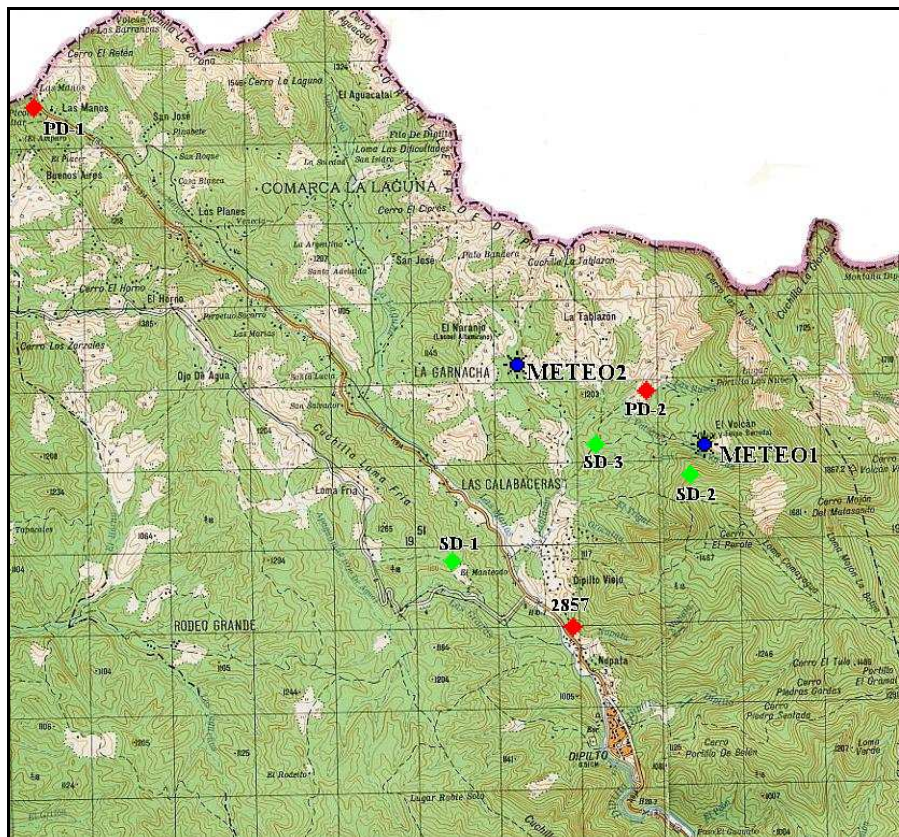
The first step was to setup the primary and secondary order networks to which further observations can be linked. To reduce uncertainties in further measurements, 3 points are used for each network. At the time of writing the coordinates obtained by the department of Geodesy of INETER were unavailable. Preliminary coordinates obtained using my own handheld GPS are given in *Annexe 2*. These networks are only necessary if measurements are done using traditional triangulations methods. There were three stations of primary order (from the national network) already installed in the area. One in Dipilto next to the main road to Las Manos, one on the top of Cerro El Volcan and one on the top of Cerro La Picona, next to Las Manos, on the Honduran border. The monument on El Volcan is inaccessible due to the presence of mines on the upper slopes and could not be used. La Picona is at the border and would cause border crossing difficulties. It is also covered by trees and therefore could not be used. Only the one in Dipilto (2857-II), next to the main road, was easily accessible. For the other two points, one was chosen next to Las Manos, on the slopes of La Picona (PD-1) and one at the small chapel (PD-2). The points of secondary order are closer to the target zone, on stable areas. The furthest is on a hill in El Manteado (SD-1) and the other two closer to the landslide, on the crest above the Cooperative and next to the school (SD-2 and SD-3 respectively). See *figure 8* below.

*Figure 8: Localisation of the points of primary (in red lozenges) and secondary order (in green lozenges). The meteorological stations are in blue.*

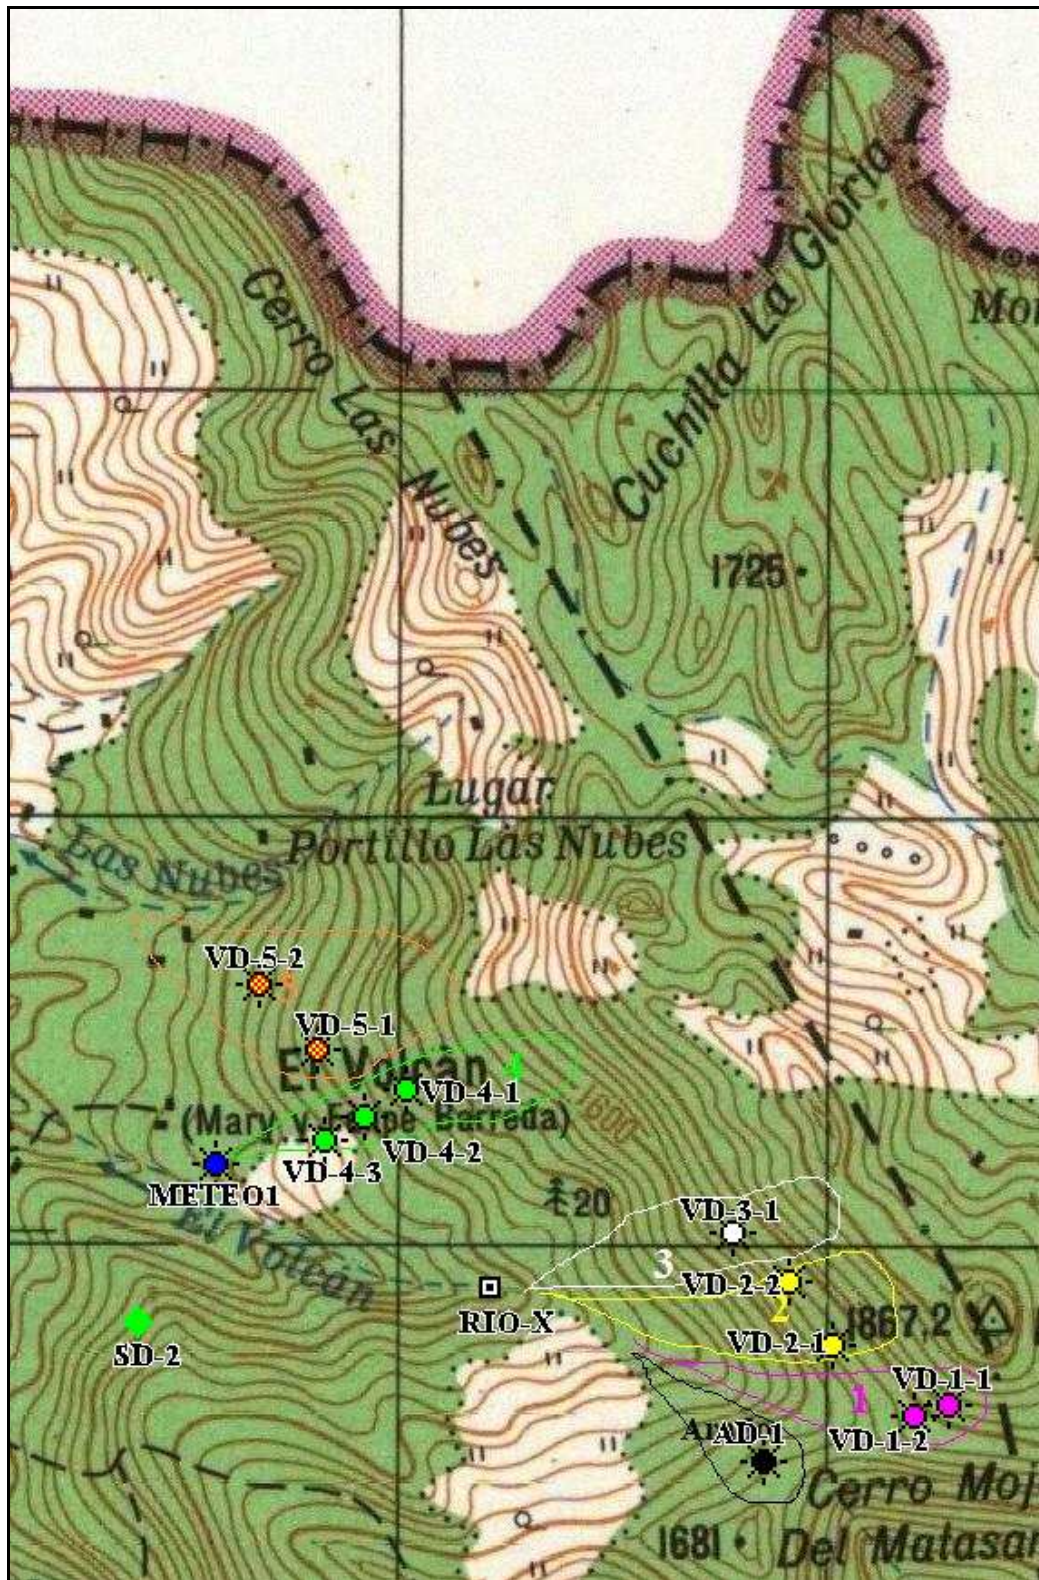
During the campaign, we walked through each compartment in order to determine the most adequate position for the geodesic monuments. Where possible, we positioned them in the most active parts, above and below the main scarps and where the movements are the most evident. If several scarps were present, we installed several monuments in order to detect the respective movements in this compartment. The coordinates are in *Annexe 2* and the locations shown in *figure 9*. From all tertiary monuments, we can see two points of secondary networks. It's not important if we only use differential GPS for the measures but would be necessary if using traditional triangulation methods.

*Figure 9:* Location of monuments within the compartments. We used the same colours as for figure 4 to draw the compartments: Arado in black, C1 in purple, C2 in yellow, C3 in white, C4 in green and C5 in orange.

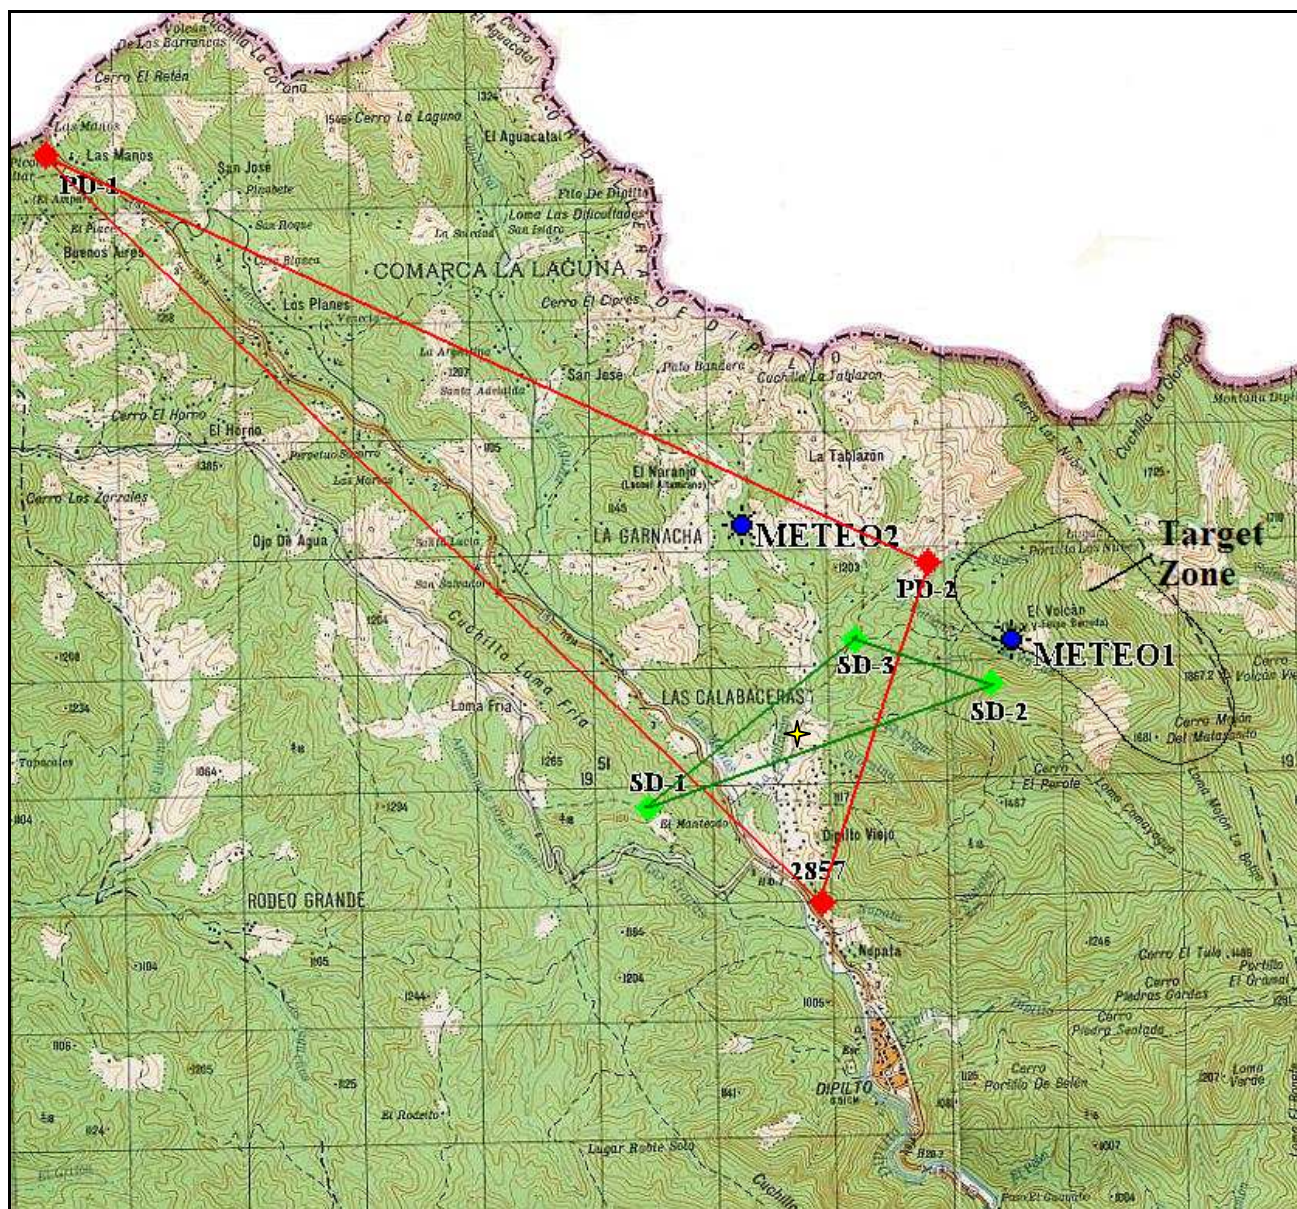
Figure 10: Triangulations between the stations. I have just noted for clarity the primary (in red) and secondary (in green) networks. The actual measures are always done between 2 primary stations and 1 secondary station.

Some triangulations have long and flat shapes, like PD-1/2857/SD-1. I am aware that SD-1 would have been in a better location in Las Bromas (see the yellow star on the previous map) because less far to the studied area, enabling a better triangulation and visible from all tertiary points. It could be worth trying again to put a monument after some negotiations with the owner of the land...

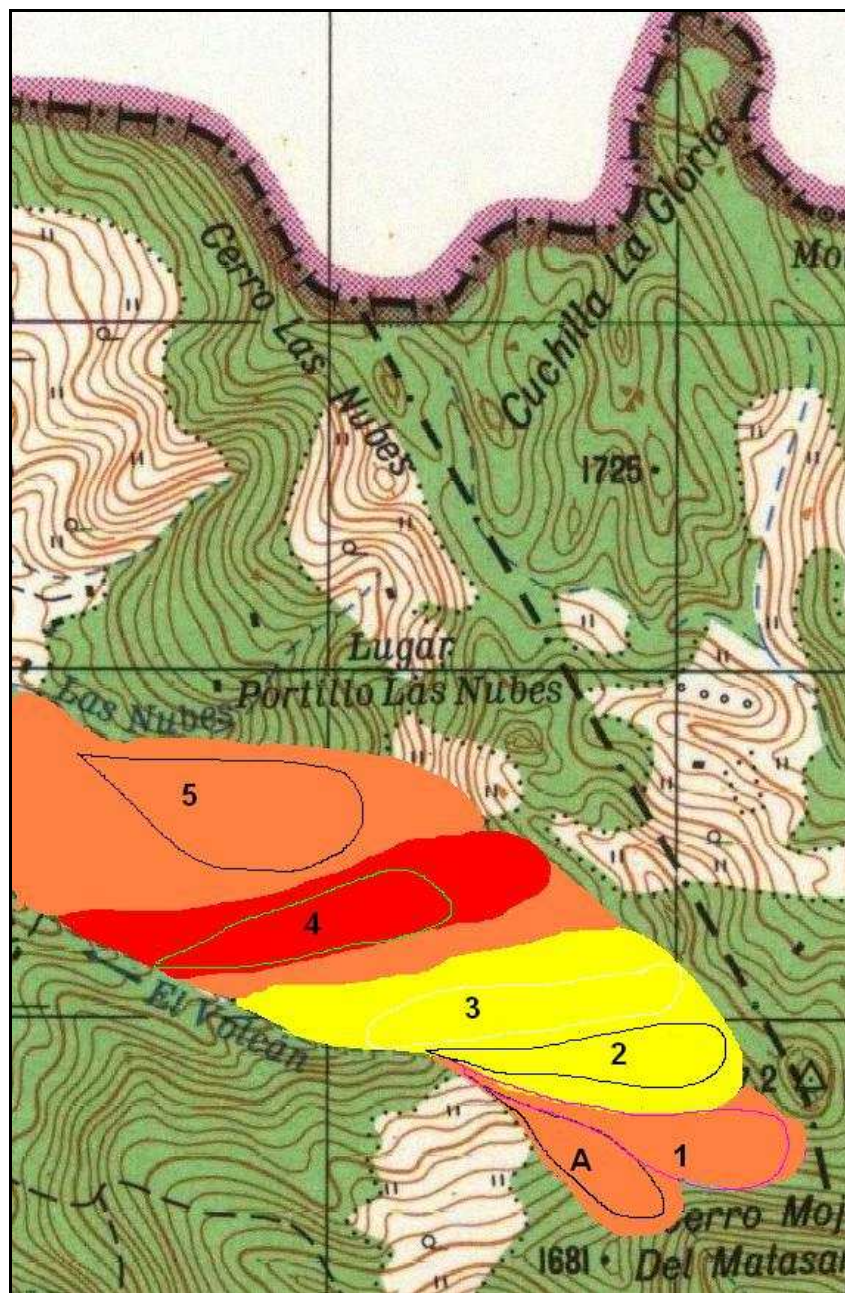
*Figure 11: Attempt of risk map in Cerro El Volcan area.*

I estimated that deep-seated landslides, located in Arado, compartments 1, 4 and 5, are more dangerous than superficial landslides (compartments 2 and 3). Their velocity is probably comprised between 2 and 10cm/year. These zones will be attributed a medium to high danger level. The element at risk most prone to landslides and debris flows is the Cooperative. By combining preceding information, I chose to give a high risk to the area around compartment 4, medium risk to zones around Arado, compartment 1 and 4 and low risk to zones comprising compartments 2 and 3. Transition zone between compartment 3 and 4 are medium risk because scarps and deeper movements are suspected (we can see numerous scarps but there is no access) and it represents a transition between low and high risk zones. Areas are then extended to the watershed to take into account debris flow hazards.

On the map, three levels of risk are defined: high (in red), medium (in orange) and low (in yellow).
